Louisiana Housing Finance Agency

Asset Management Committee

September 13, 2011

Project Name:
Mid City Gardens I & II Residential
(Replacement of Capital City South Apartments)
A New Mixed Use Project in South Baton Rouge
for Louisiana Housing Finance Agency

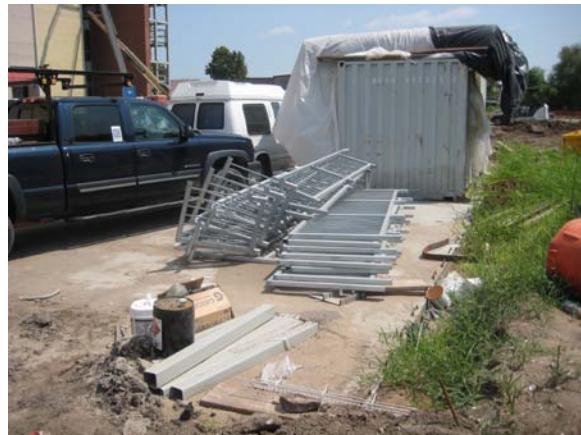
84. 14 The general contractor advised that all steel supports for Volume 4 tube steel screens are on site; however, none are painted. They intend to set up a paint shop on site utilizing a large greenhouse frame with a cover in order to field paint these items prior to installation. H/S voiced concern regarding the presence of rust at the connections of the tube steel frame corners. Mr. Broughton responded that this was due to the galvanizer

being unable to galvanize the entire frame in their vats, therefore, the returns on each side of the balcony were welded after galvanizing was complete. Proper treatment of these areas, including removal of rust and cold galvanizing will be required prior to painting.

Repair needed at rusted connections for tube steel screen supports. Screens arrived unpainted.
